COUNTIES (MD/PA) _	WASHINGTON/FRANKLIN
M&D milestone no.	97 (100)
MHT-HSI no.	WA-I-484

FIELD SHEET: MASON & DIXON LINE, MARYLAND-PENNSYLVANIA BOUNDARY MARKER SURVEY

1979-81 Inspection notes: order no. 97 (100); photos/negatives/slides no. 97 (100) 97 (100). Original M&D milestone of 1767 in place, in fair condition, firmly set. Most of E/S chipped off; letters distinct, but all surfaces badly weathered and nicked; chips all edges and corners. BM set in apex. Protected by site.

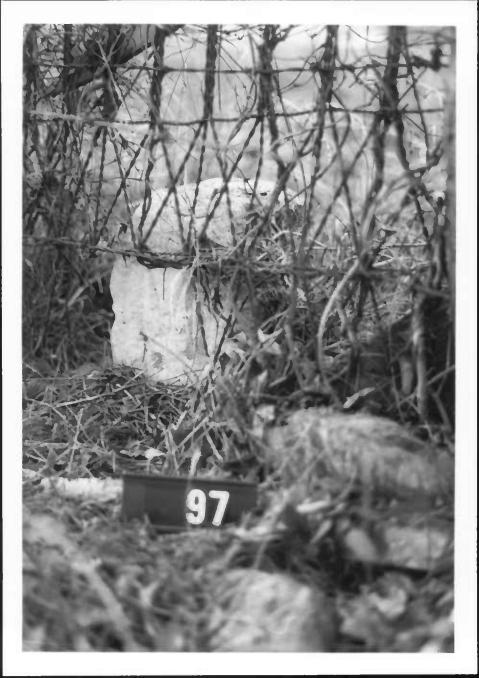
MASER FIXER SETLINE: MILESTONE 9 (1)

SECENER (M/-)

PHOTO: PLICE HARTIN (1980. 27. 124) 10/2 80

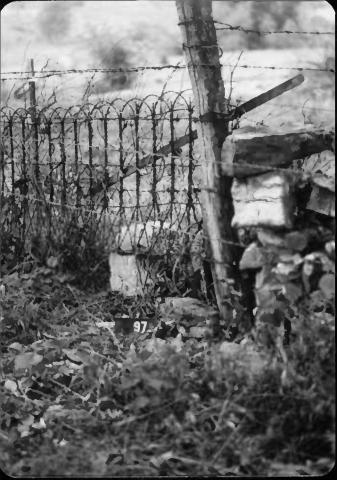
MASON EDIXON WEST LINE: MILESTONE 97(100)

SE CORDER SHOWING WEND OF

PRONE WALL REMAINS + STONE +

OPEN FIELDS TO NW

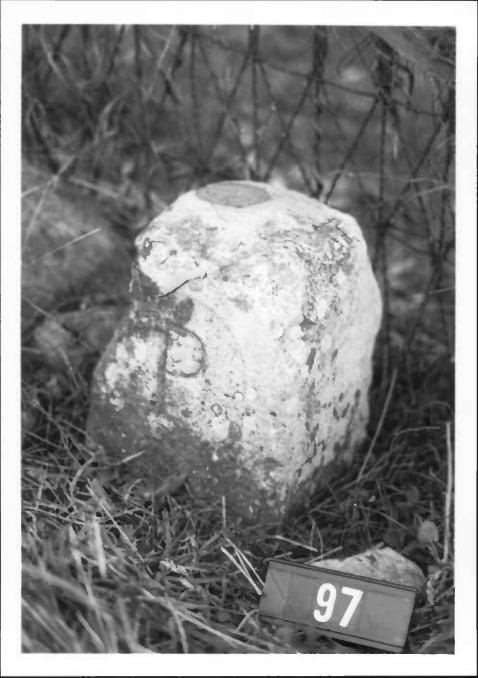
MASON & DIXON WEST LINE: MILESTONE 97 (100)

limestone post; standing about 1' above ground; P on N/S, M on S/S
N face (PA): 11½" wide x 13½" high; P & most of circle panel distinct; no fluting
or margins remain; surfaces very weathered & nicked

NW CORNER (P)-

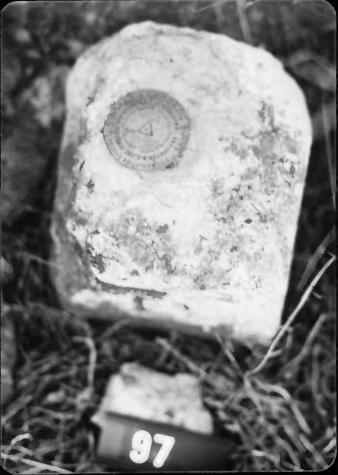
MASON EDIXON WEST LINE: MILESTONE 97 (100) OFF N/S MILERS CHURCH RD

114" wide x 131/2" high; no fluting or margins remain; surfaces very weatherworn; chips all edges & corners
still cracking from setting of BM disk in apex; huge chunk out of
top E edge; big chips all edges & corners; weatherworn, no planes
BM 645 (1959) USCEGS triangulation station disk in apex top:

Mrs. Belew (Clara) was very hospitable and helpful; gave us good directions as to how to find stone, and allowed us to park in her drive. The stone was badly damaged by setting of the triangulation station disk, is still cracking (apparently from this); and, as can be seen from the B&W photos more chips were ready to drop off the top. MGS will want to contact owners of property surrounding the stone, secure any loose chips and make sure the stone is not further damaged. Whoever inspects this next may want to approach site simply following E-W fenceline from Shoemaker Rd E (if field is still open and grassy). In this case: contact family at interesting old stone farmhouse W/S Shoemaker Rd (who can observe anything going on in that field!)

CLOSEUP OF TOP & TRIANGULATION STATION DISK (BNDRY MON NO 97 1939) FROM NIS OF MILESTENE NOTE: MUCH OF EAST FACE IS GONE PHOTO: ALKE MARTIN (1980.27.16A)
